48 PRESERVATION BRIEFS

Preserving Grave Markers in Historic Cemeteries

Mary F. Striegel, Frances Gale, Jason Church, & Debbie Dietrich-Smith

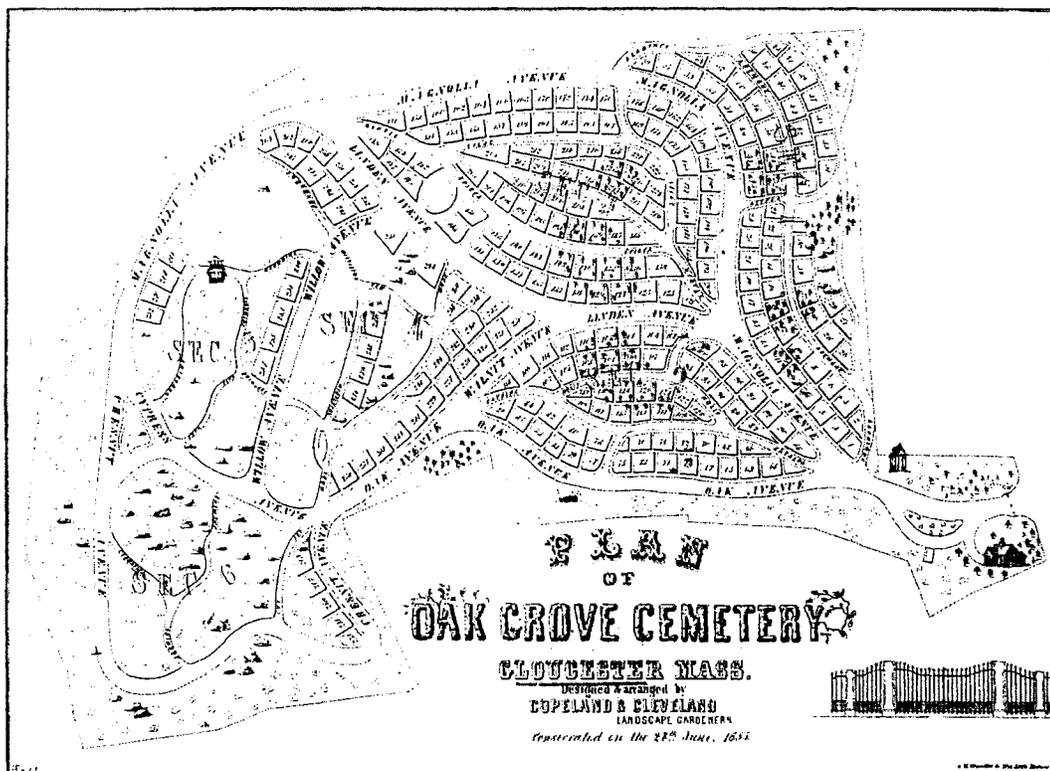
The 1855 plan of the Oak Grove Cemetery in Gloucester, Essex County, Massachusetts, is an important source of cemetery documentation. (James O’Gorman, 1975)

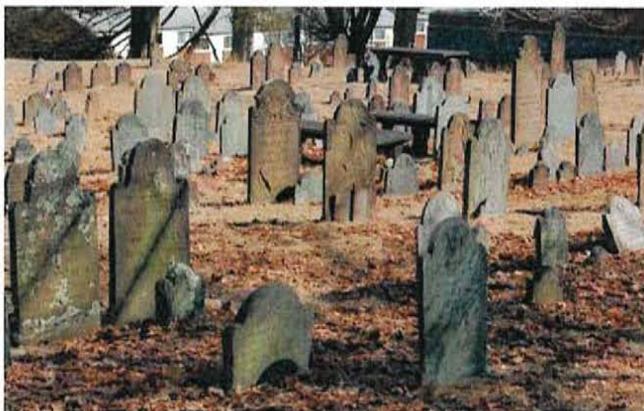
Figure 1. Sandstone and slate grave markers in the Ancient Burying Ground in New London, CT, display a variety of weathering conditions. Markers in the cemetery date from the mid-17th to the early 19th centuries. Photo: Jason Church.

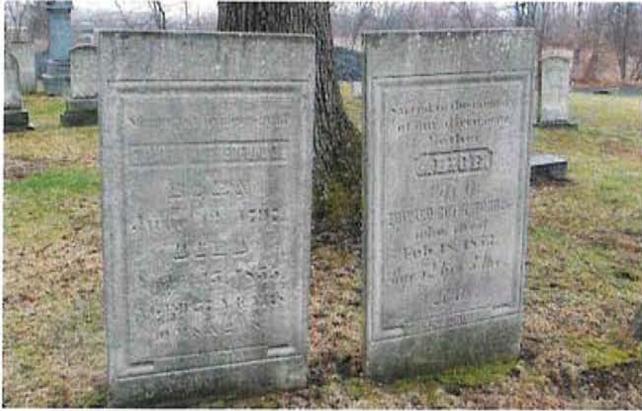
Figure 2. These mid-19th century, single-element stone grave markers in the Grove Cemetery in Bath, NY, are set in a vertical position. Photo: Jason Church.

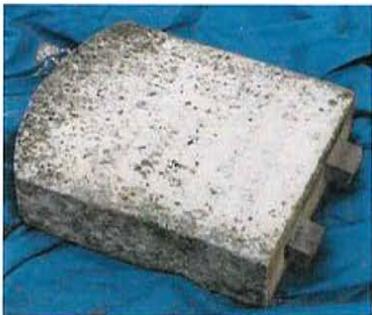
Figure 3. A multi-element grave marker from the early 19th century in the St. Michael's Cemetery, Pensacola, FL, consists of a vertical element with tabs (left image) into a slotted base (right image). Photo: Fran Gale.

Multiple-element grave markers are found in a number of different forms (Fig. 3). In the most typical form, a grave marker would consist of two stones—an upper headstone placed on top of a base stone. The upper headstone may be secured in a number of different ways to the base. In the simplest of forms, the upper stone was placed on the base, set in a bed of mortar on top of the base, or joined with pins and mortar. With a “tab-and-

slot” grave marker, the tabbed upper stone was set in a slotted base. More common today, the upper headstone is secured with a technique that uses small spacers set on the base and a setting compound. This technique or one that uses an epoxy adhesive may be found on older markers where the stones have been reset.

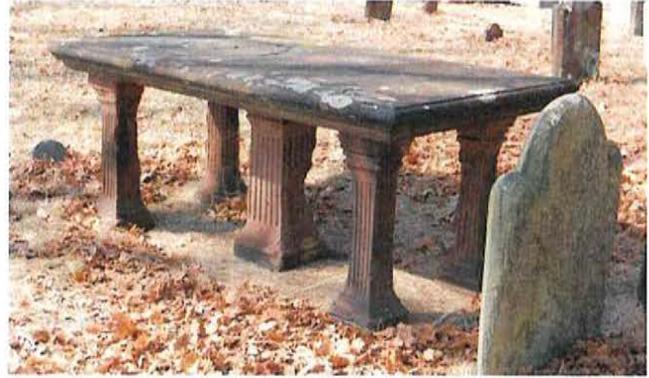
Figure 4. This sandstone table tomb, located in Cedar Grove Cemetery, New London, CT, is an engineered grave marker structure consisting of a horizontal stone tablet supported by four vertical table “legs” with and a central column,. Photo: Jason Church.

Grave markers can also be engineered structures. Examples of grave marker structures include masonry arches, box tombs, table tombs, grave shelters, and mausoleums (Fig. 4). The box tomb is a rectangular structure built over the gravesite. The human remains are not located in the box itself as some believe, but rather in the ground beneath the box structure. The table tomb is constructed of a horizontal stone tablet

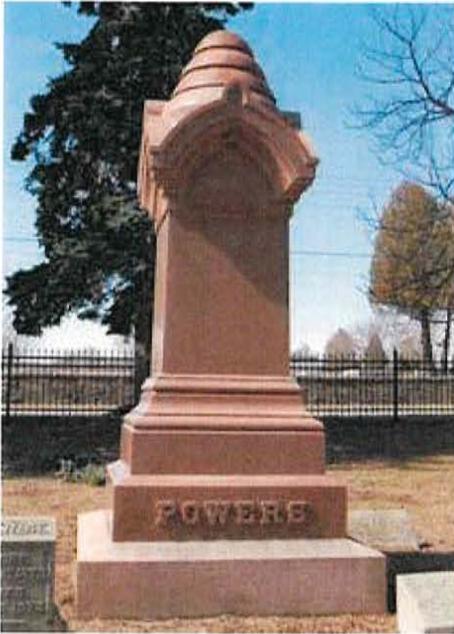
Figure 5. A variety of colors of natural stone are found in historic cemeteries, such as this pink granite marker in the Cedar Grove Cemetery, New London, CT. Photo: Jason Church.

Stone is a naturally occurring material with a wide range of properties and is available in a variety of colors (Fig. 5). Geologists classify stone according to the way in which it was formed with the three categories being igneous, sedimentary and metamorphic rock. Stone found in cemeteries is predominantly quarried, though the use of field stones is not uncommon. The mineralogy and chemical composition of stones vary. Some are composed primarily of silicate minerals; granites, sandstones, slate, and schist are examples. Other stones contain calcium carbonate with marble and limestone in this group. Mineralogy, chemical composition, and physical structure of the stone influence weathering and

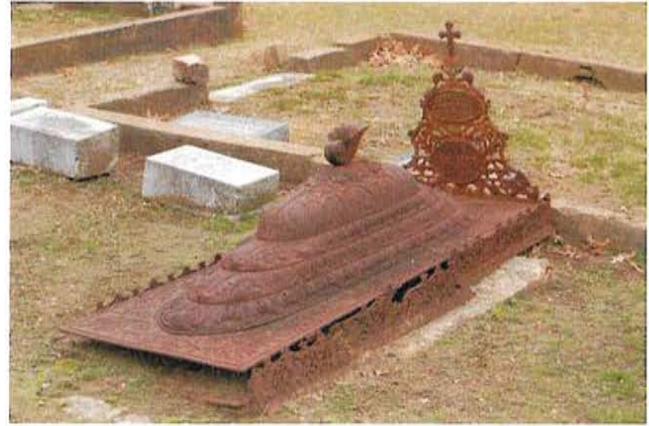
Figure 6. Decorative cast-iron grave markers like this late-19th century one in Oakland Cemetery in Shreveport, LA, are produced by heating the iron alloy and casting the liquid metal into a mold. Photo: Jason Church.

Metals are solid materials that are typically hard, malleable, fusible, ductile, and often shiny when new (Fig. 6). A metal alloy is a mixture or solid solution of two or more metals. Metals are easily worked and can be melted or fused, hammered into thin sheets, or drawn into wires. Different metals have varying physical

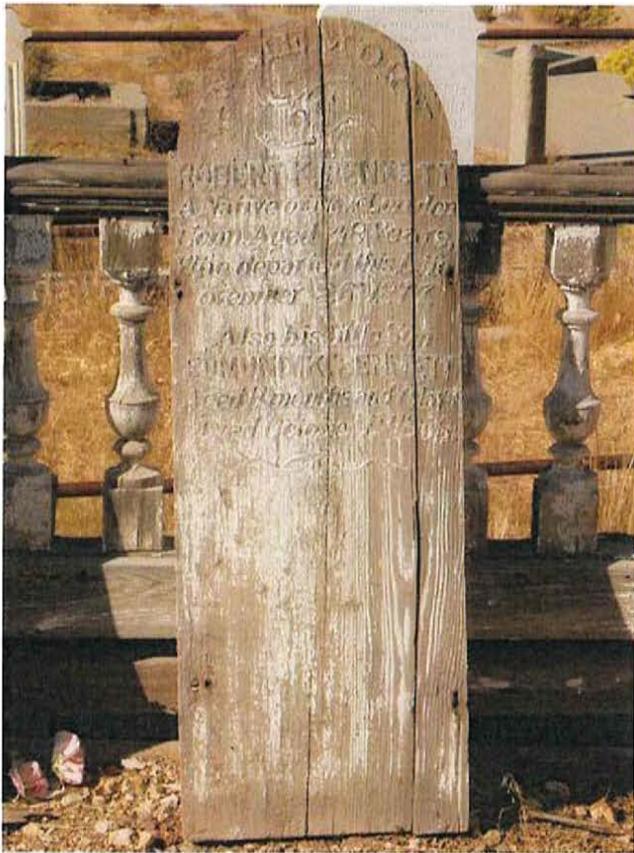
Figure 7. As shown by this 1877 marker in Silver Terrace Cemetery, Virginia City, NV, exposure to sunlight can damage wood grave markers, making the wood more susceptible to water damage and cracking. Photo: Jason Church.

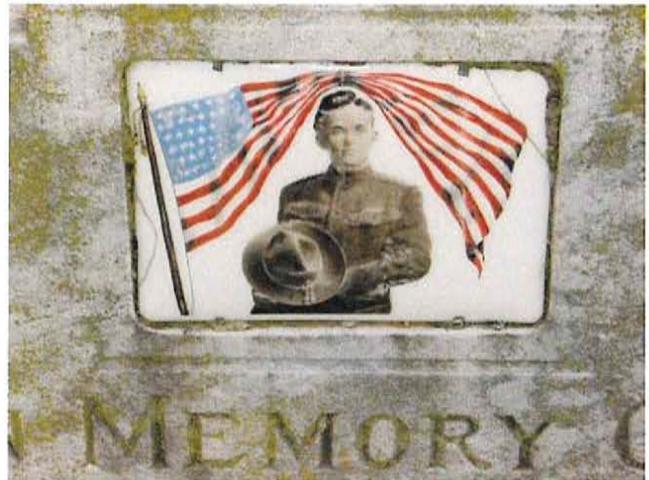
Figure 8. A fired ceramic, this cameo is set in a marble grave marker, located in Elmwood Cemetery, Memphis, TN. Different materials may require different conservation approaches. Photo: Mary Striegel.

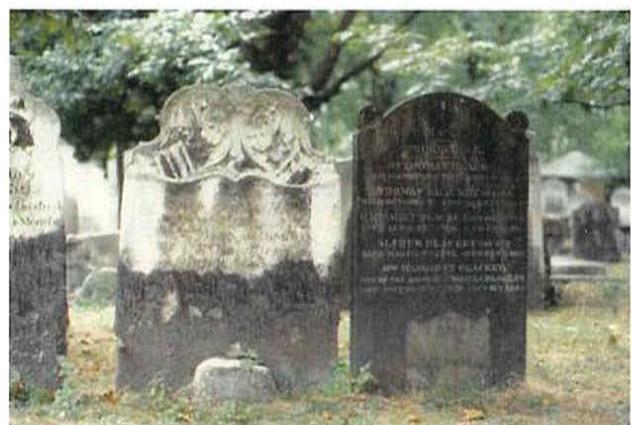
Figure 9. The limestone and sandstone grave markers in this historic cemetery have different weathering processes. On the left, the limestone shows surface loss in areas exposed to rainwater and gypsum crust formation below. The sandstone marker on the right displays uniform soiling, but surface hardening may be occurring. Photo: Fran Gale.

All grave marker materials deteriorate when they are exposed to weathering such as sunlight, wind, rain, high and low temperatures, and atmospheric pollutants (Fig. 9). If a marker is composed of several materials, each may have a different weathering rate. Some weathering processes occur very quickly, and others gradually affect the condition of materials. Weathering results in deterioration in a variety of ways. For example, when exposed to rainwater some stones lose surface material while others form harder outer crusts that may detach from the surface.

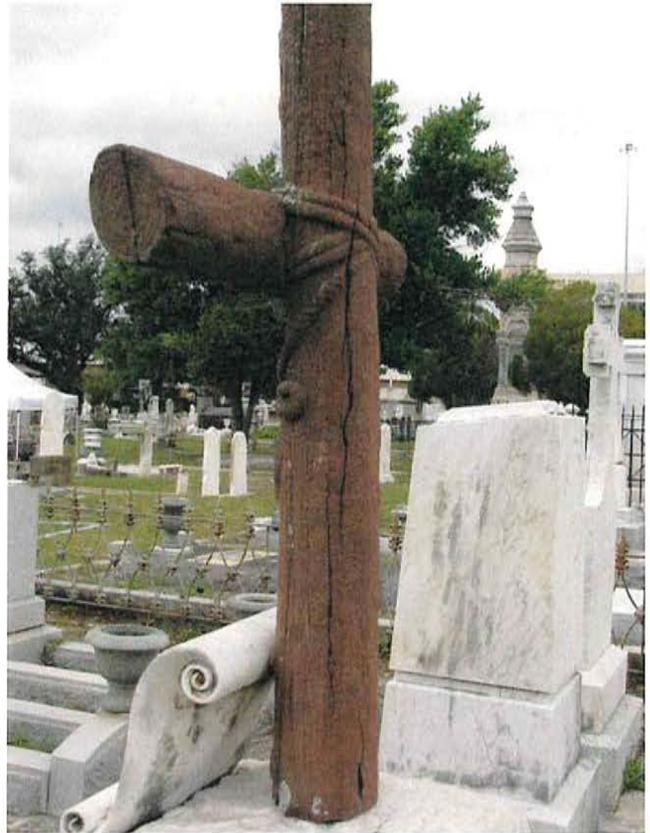
Figure 10. The sandstone cross (carved to look like wood) in this grave marker in St. Michael's Cemetery in Pensacola, FL, provides an example of inherent vice – the severe delamination affecting the sandstone has occurred along its natural bedding planes. Photo: Fran Gale.

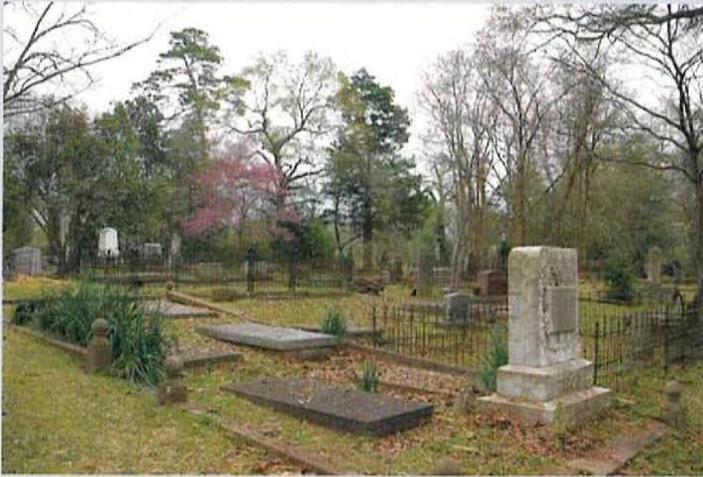
Figure A. Cemeteries are cultural landscapes made up of a variety of features. Grave markers are but one component of cemeteries that also include walkways, drives, fences, coping, trees, shrubs, and other vegetation. Each component adds to the understanding of the cemetery landscape. Photo: Debbie Dietrich Smith.

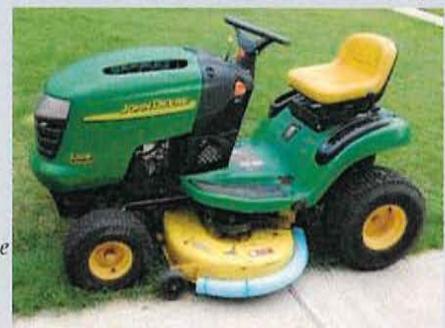
Figure B. A pool 'noodle' can be fitted to the deck of a lawnmower to prevent damage to grave markers. Photo: Debbie Dietrich Smith.

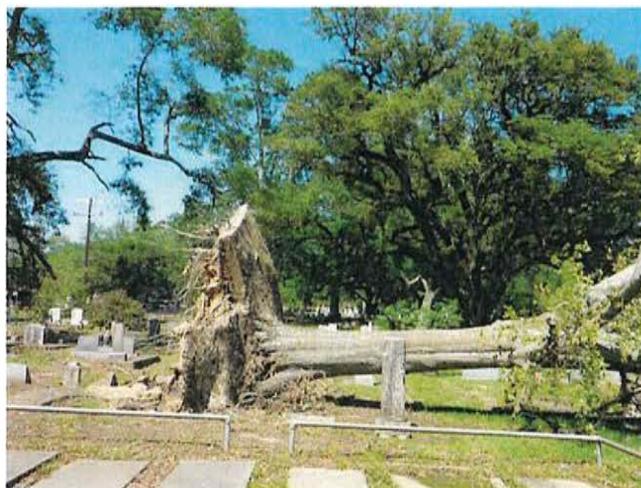
Figure 11. Woody vegetation can damage grave markers and pose a risk to visitors unless well managed and maintained. Photo: Jason Church.

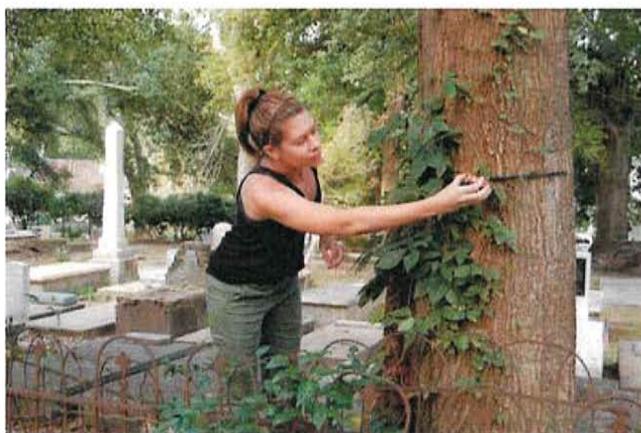
Figure 12. A cemetery professional undertakes a tree inventory in American Cemetery, Natchitoches, LA, to determine the health of trees in the cemetery. Management decisions for trimming or removal are based on the inventory. Photo: Debbie Dietrich Smith.

Woody vegetation can damage grave markers in a variety of ways (Fig. 11). Trees, bushes, and vines can shade grave markers, extending the time that the markers are exposed to moisture. Tendrils and roots may burrow into mortar joints and openings, causing mechanical damage and large plants may lift up or shift markers. Even leaves and twigs, when allowed to collect on the ground near grave markers, can affect water drainage and evaporation (Fig. 12).

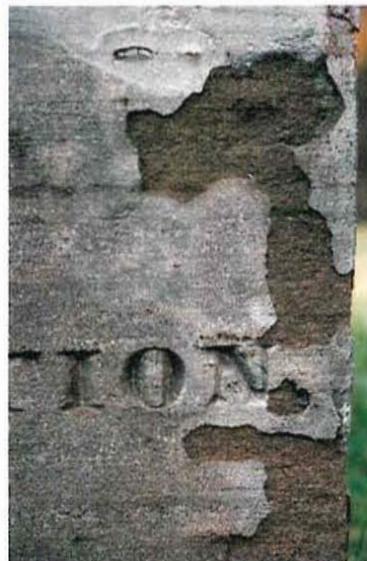
Figure 14. High-pressure water washing can damage grave markers. The photograph shows "wand marks" on the headstones produced by inappropriate pressure washing. Photo: Jason Church.

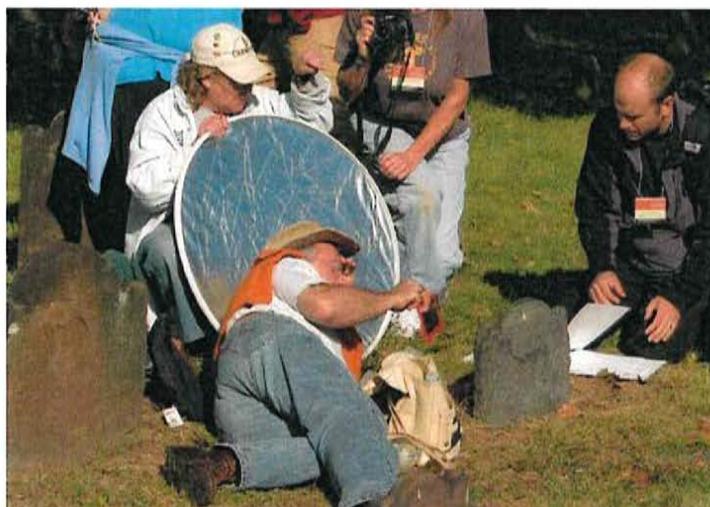
Figure 15b. Photographs are used to document the condition of the grave marker as part of a condition assessment. Photo: Fran Gale.

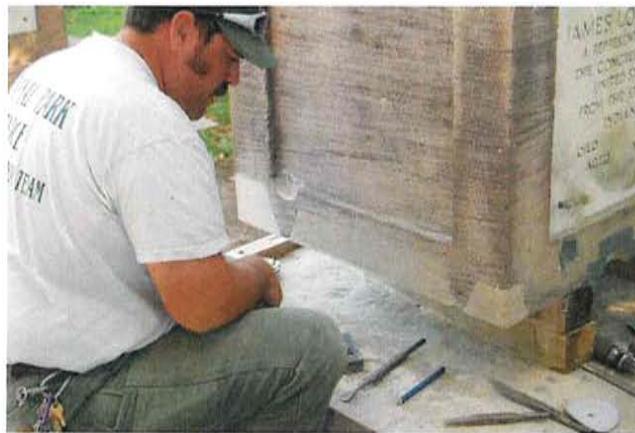
Figure 16. A professional mason works to insert a new piece of stone. Often referred to as a “dutchman”, this repair technique requires replacing the deteriorated stone section with a new finished piece of the same size and material. Photo: Jason Church.

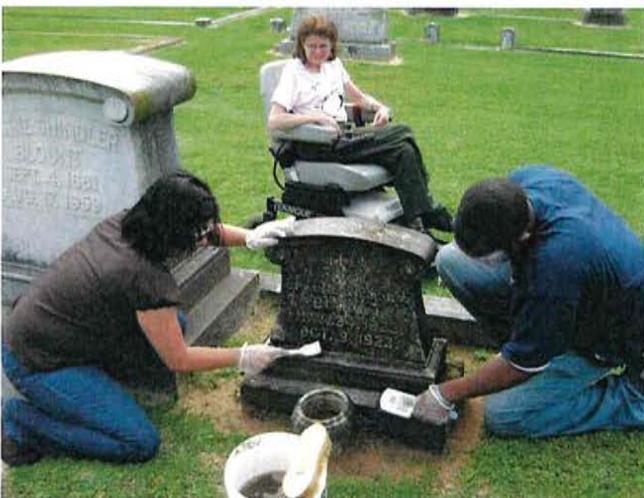
Figure 17. Volunteers can undertake cleaning of grave markers once they have received initial training. Cleaning methods may include wetting the stone, using a mild chemical cleaner, gently agitating the surface with a soft bristle brush, and thoroughly rinsing the marker with clean water. Photo: Jason Church.

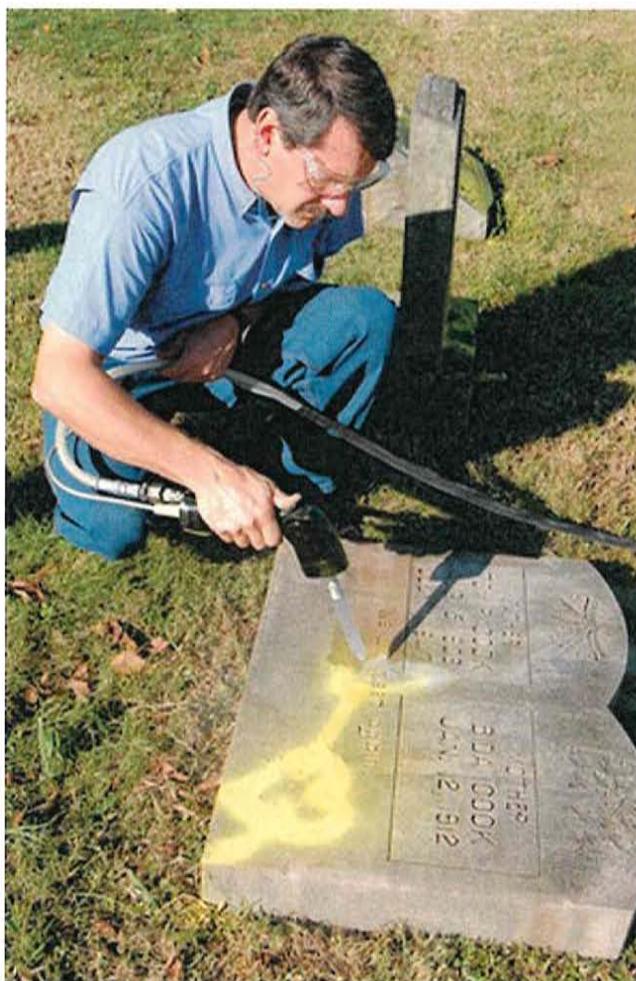
Figure 18. Graffiti is carefully removed using a low-pressure dry-ice misting instrument. Photo: Jason Church.

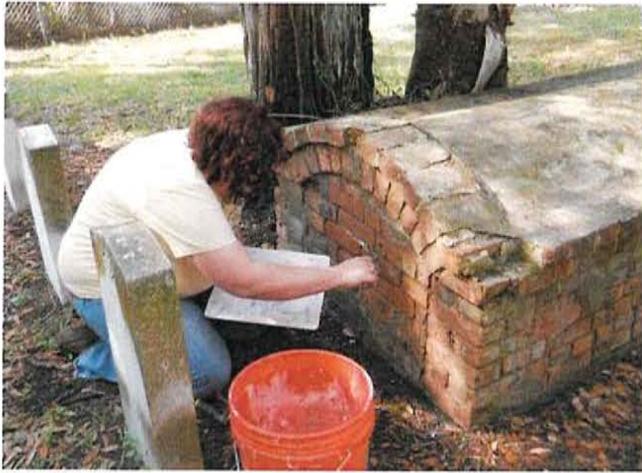
Figure 19. Masonry markers like this box tomb may require the repointing of mortar joints. It is important to use a mortar that is softer than the historic brick. In this case a conservator uses a lime putty-based mortar to repoint. Photo: Jason Church.

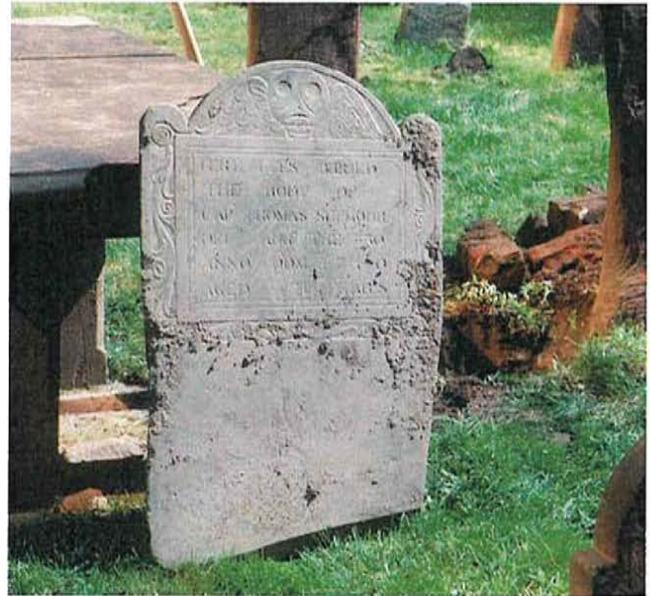
Figure 20a. This slate grave marker in the Ancient Burying Ground in Hartford, CT, is a ground-support stone. Resetting requires digging a hole that will hold the base of the stone and then compacting the soil at the bottom of the hole by hand. Photo: Fran Gale.

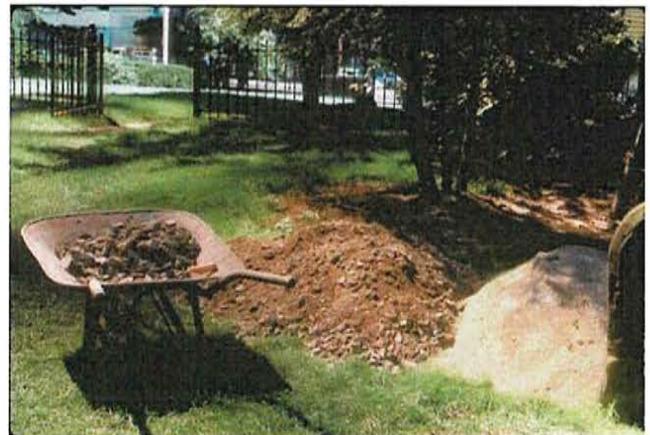
Figure 20b. To facilitate drainage, crushed stone, gravel, and sharp sand line the hole and are hand-tamped around the stone after placement. Photo: Fran Gale.

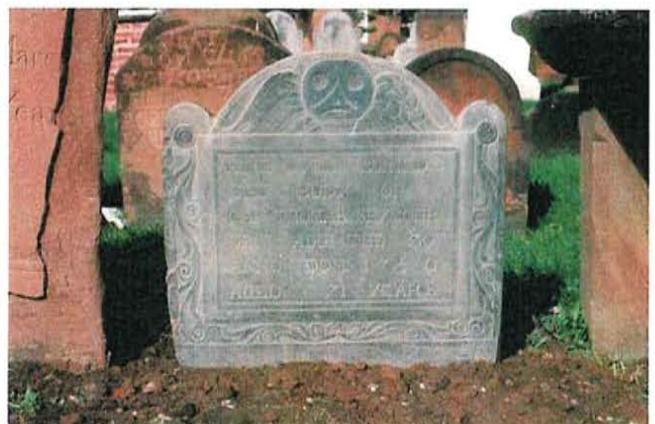
Figure 20c. The reset ground-supported grave marker should be level and plumb. Photo: Fran Gale.

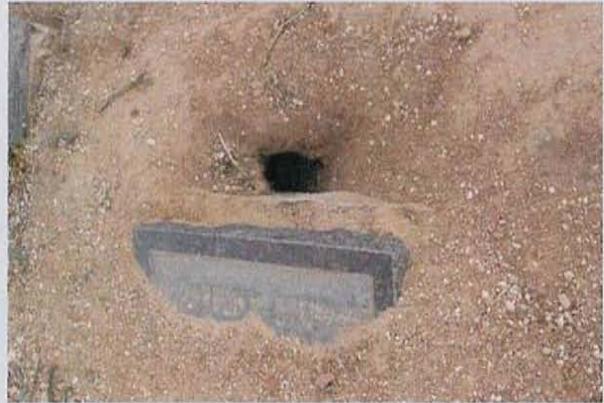
Figure C. Gophers and other burrowing animals produce uneven ground and holes that are trip and falling hazards to visitors and staff of historic cemeteries. Photo: Jason Church.

Trip and falling hazards include uneven ground, holes, open graves, toppled grave markers, fallen tree limbs, and other debris (Fig. C). Sitting, climbing, or standing on a grave marker should be avoided since the additional weight may cause

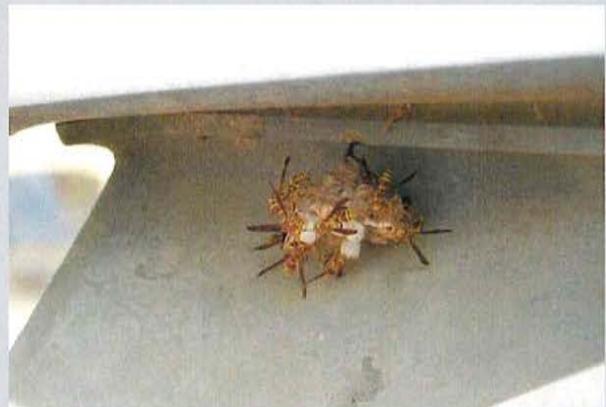
Figure D. Yellow jackets that are nesting below the projecting molding of this grave marker pose a hazard to visitors and staff because, if disturbed, they will vigorously defend their nest. Yellow jacket, paper wasp and hornet nests should be removed from grave markers by trained staff or specialists. Photo: Jason Church.

Snakes, wasps, and burrowing animals inhabit historic cemeteries (Fig. D). Snakes sun on warm stones and hide in holes and ledges, so it is important to be able to identify local venomous snakes. An appropriate venomous snake management plan should be in place, and

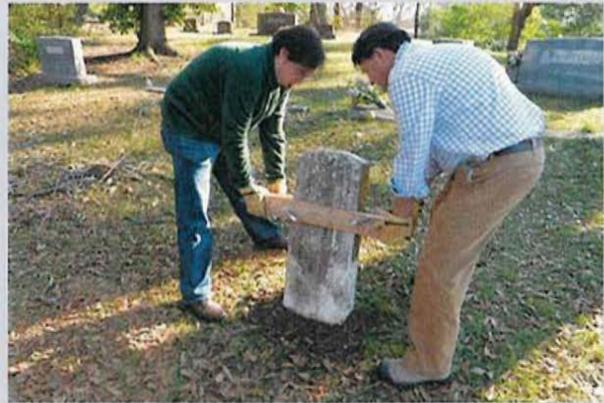
Figure E1. The simple wooden clamp system allows two people to safely lift a marble grave marker. Photo: Sarah Jackson.

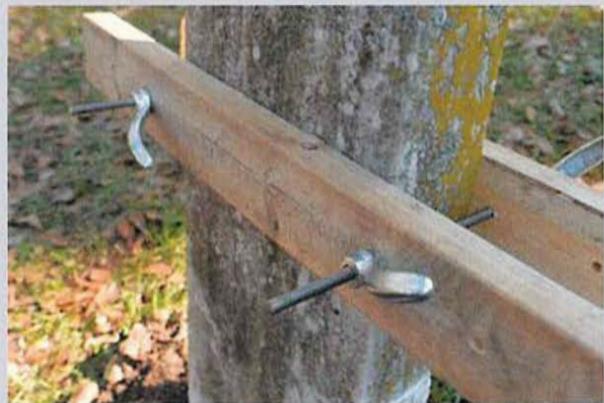
Figure E2. The clamp system is constructed from off-the-shelf wooden boards. Photo: Sarah Jackson.

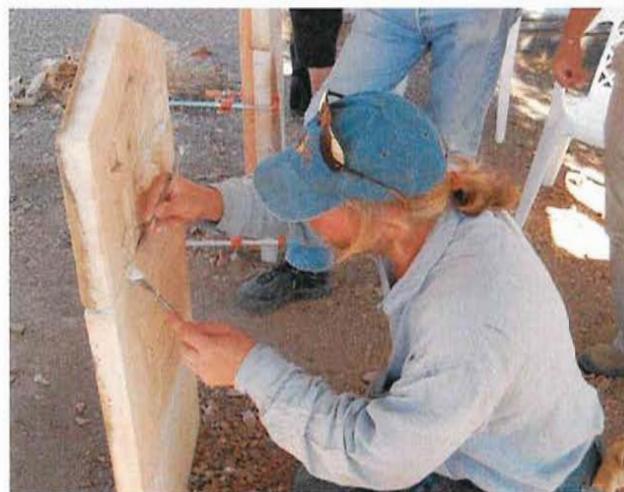
Figure 21. Cracks in a stone marker should be filled to keep water and debris out and prevent the crack from becoming larger. A patching mortar is designed to be used, in this case, with historic marble. Photo: Mary Striegel.

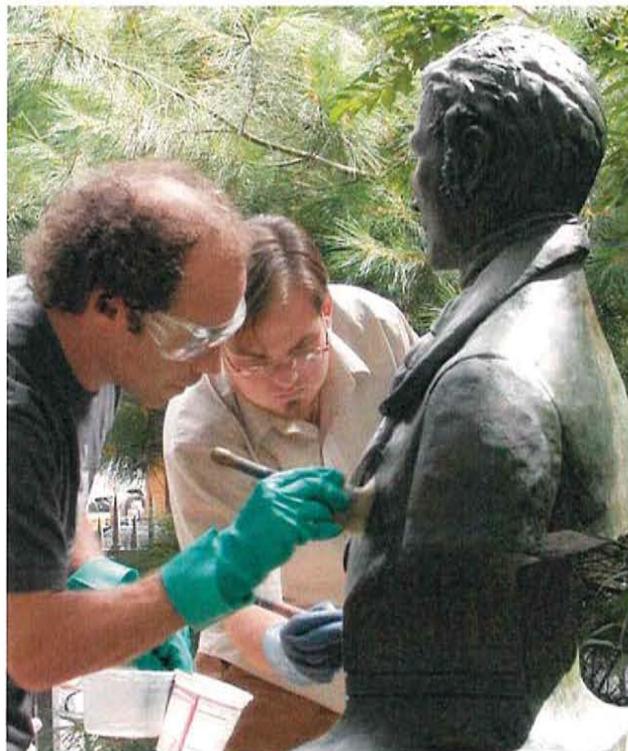
Figure 22. A protective coating must be maintained on metal elements. Wax or lacquer coatings help preserve the bronze patina and slow corrosion. Conservators apply a microcrystalline wax to this bust at St. Mark's Church in-the-Bowery, New York, NY. Photo: John Scott.

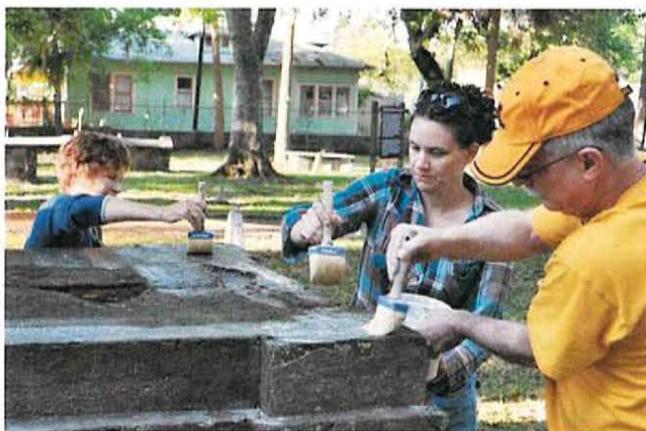
Figure 23. Limewash is a breathable coating sometimes used to protect the surface of the grave marker and provide a decorative finish. Limewash is applied by brush in five to eight thin coats (with each coat about the consistency of skim milk). The surface is allowed to slowly dry between coats. Sometimes the surface is covered by damp burlap to slow the drying process. Photo: Sarah Jackson.

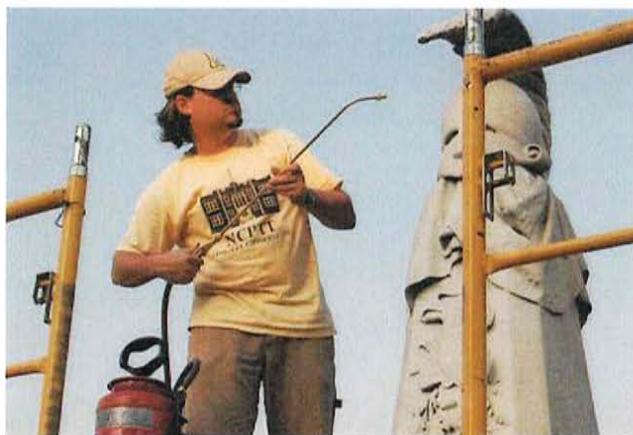
Figure 24. A severely deteriorating monument or grave marker can be treated with a stone consolidant. The treatment is usually applied using a spray system. The consolidant soaks into the stone and replaces mineral binders that hold the stone together. On-site and laboratory testing and evaluation are performed prior to using this non-reversible type of treatment. Photo: Lucas Flickinger.
